**BULK CARRIER LOSSES**  
**A NAVAL ARCHITECTS VIEWPOINT**

**B.J. CORLETT AND J.C. COLMAN**

This Paper discusses some of the background to bulk carrier losses, and in particular the role of structural failure. The principal failures likely to contribute to a total loss and the significance of heavy ore cargoes are considered from a Naval Architect's viewpoint.

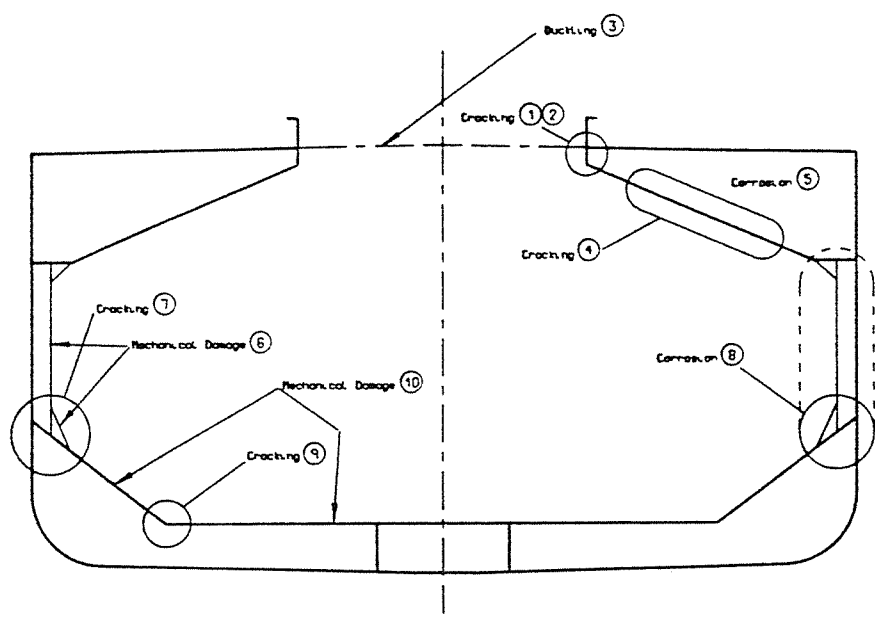
**Fig. 5.**

1. Cracking of hatch corners.
2. Cracking of hatch coamings.
3. Plate panel buckling of cross deck strips and stiffening structure.
4. Cracking at fore and aft extremities of topside tank structures.
5. Corrosion within topside tanks and double skin.
6. Grab and bulldozer damage to the main frame/lower brackets.
7. Cracking at main frame bracket toes.
8. Both general and localised corrosion of side shell, side frames and frame end brackets.

9. Cracking at the connection of the inner bottom and hopper plating.
10. Grab damage to the tank top plating, hopper and lower stool platings.

**Typical Cracking of Side Frame.**

**Typical Cracking of Side Framing.**

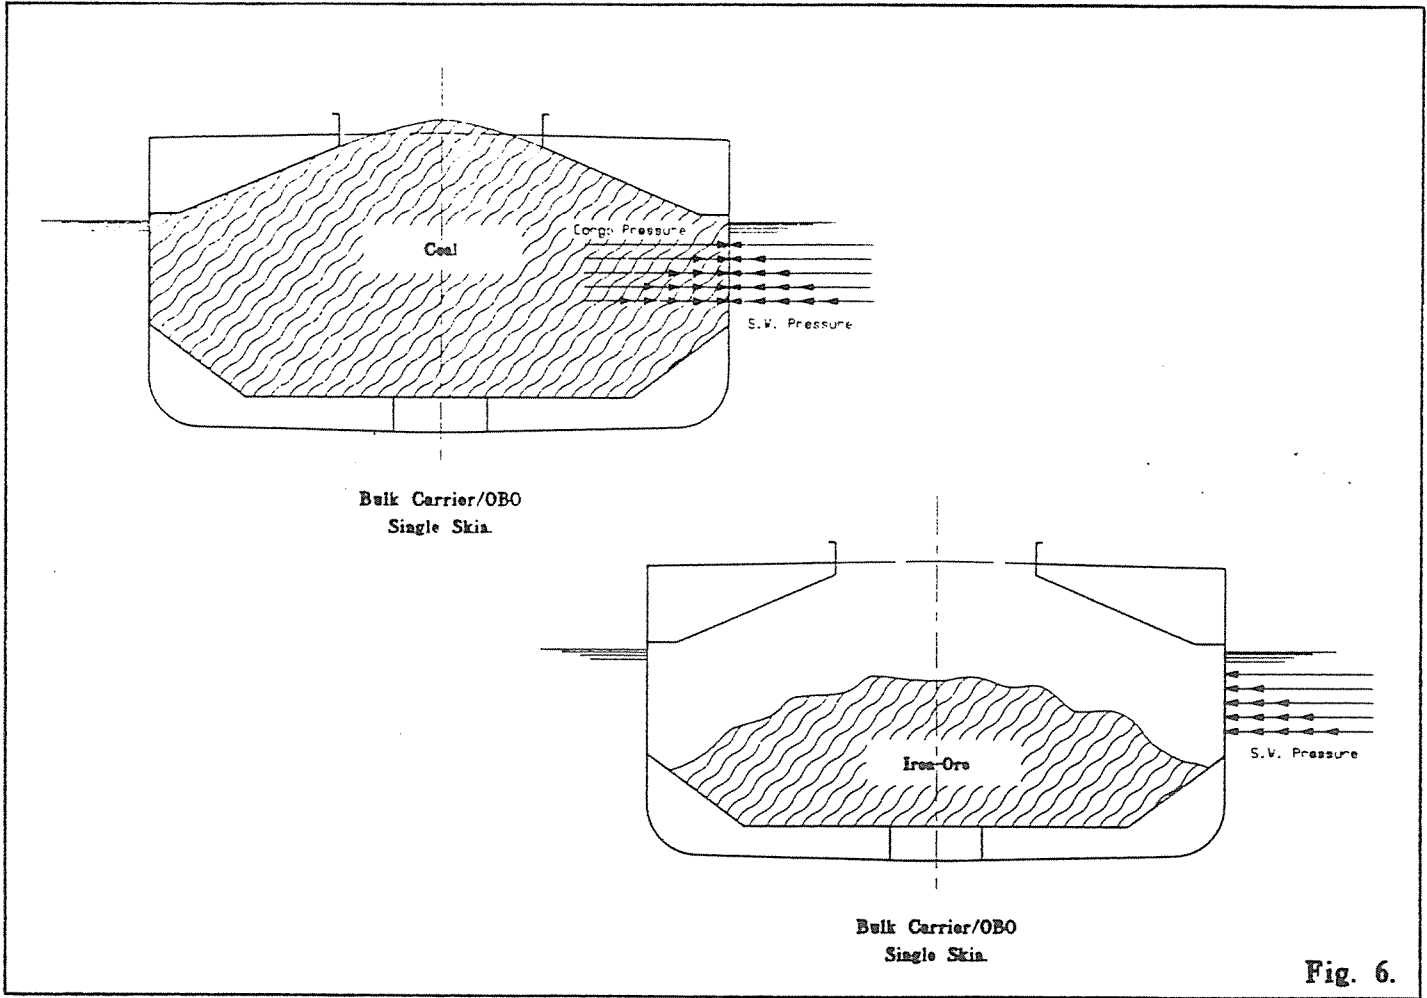
Fig. 6.

For non-dedicated ore carriers, cargoes present particular problems because of the part filled holds which result. When the hold is full of cargo, the cargo helps to support the side shell against the pressure of seawater on the outside. With an ore cargo this does not happen and so the side shell can flex more, increasing the risk of cracking and failure. (Fig.6).

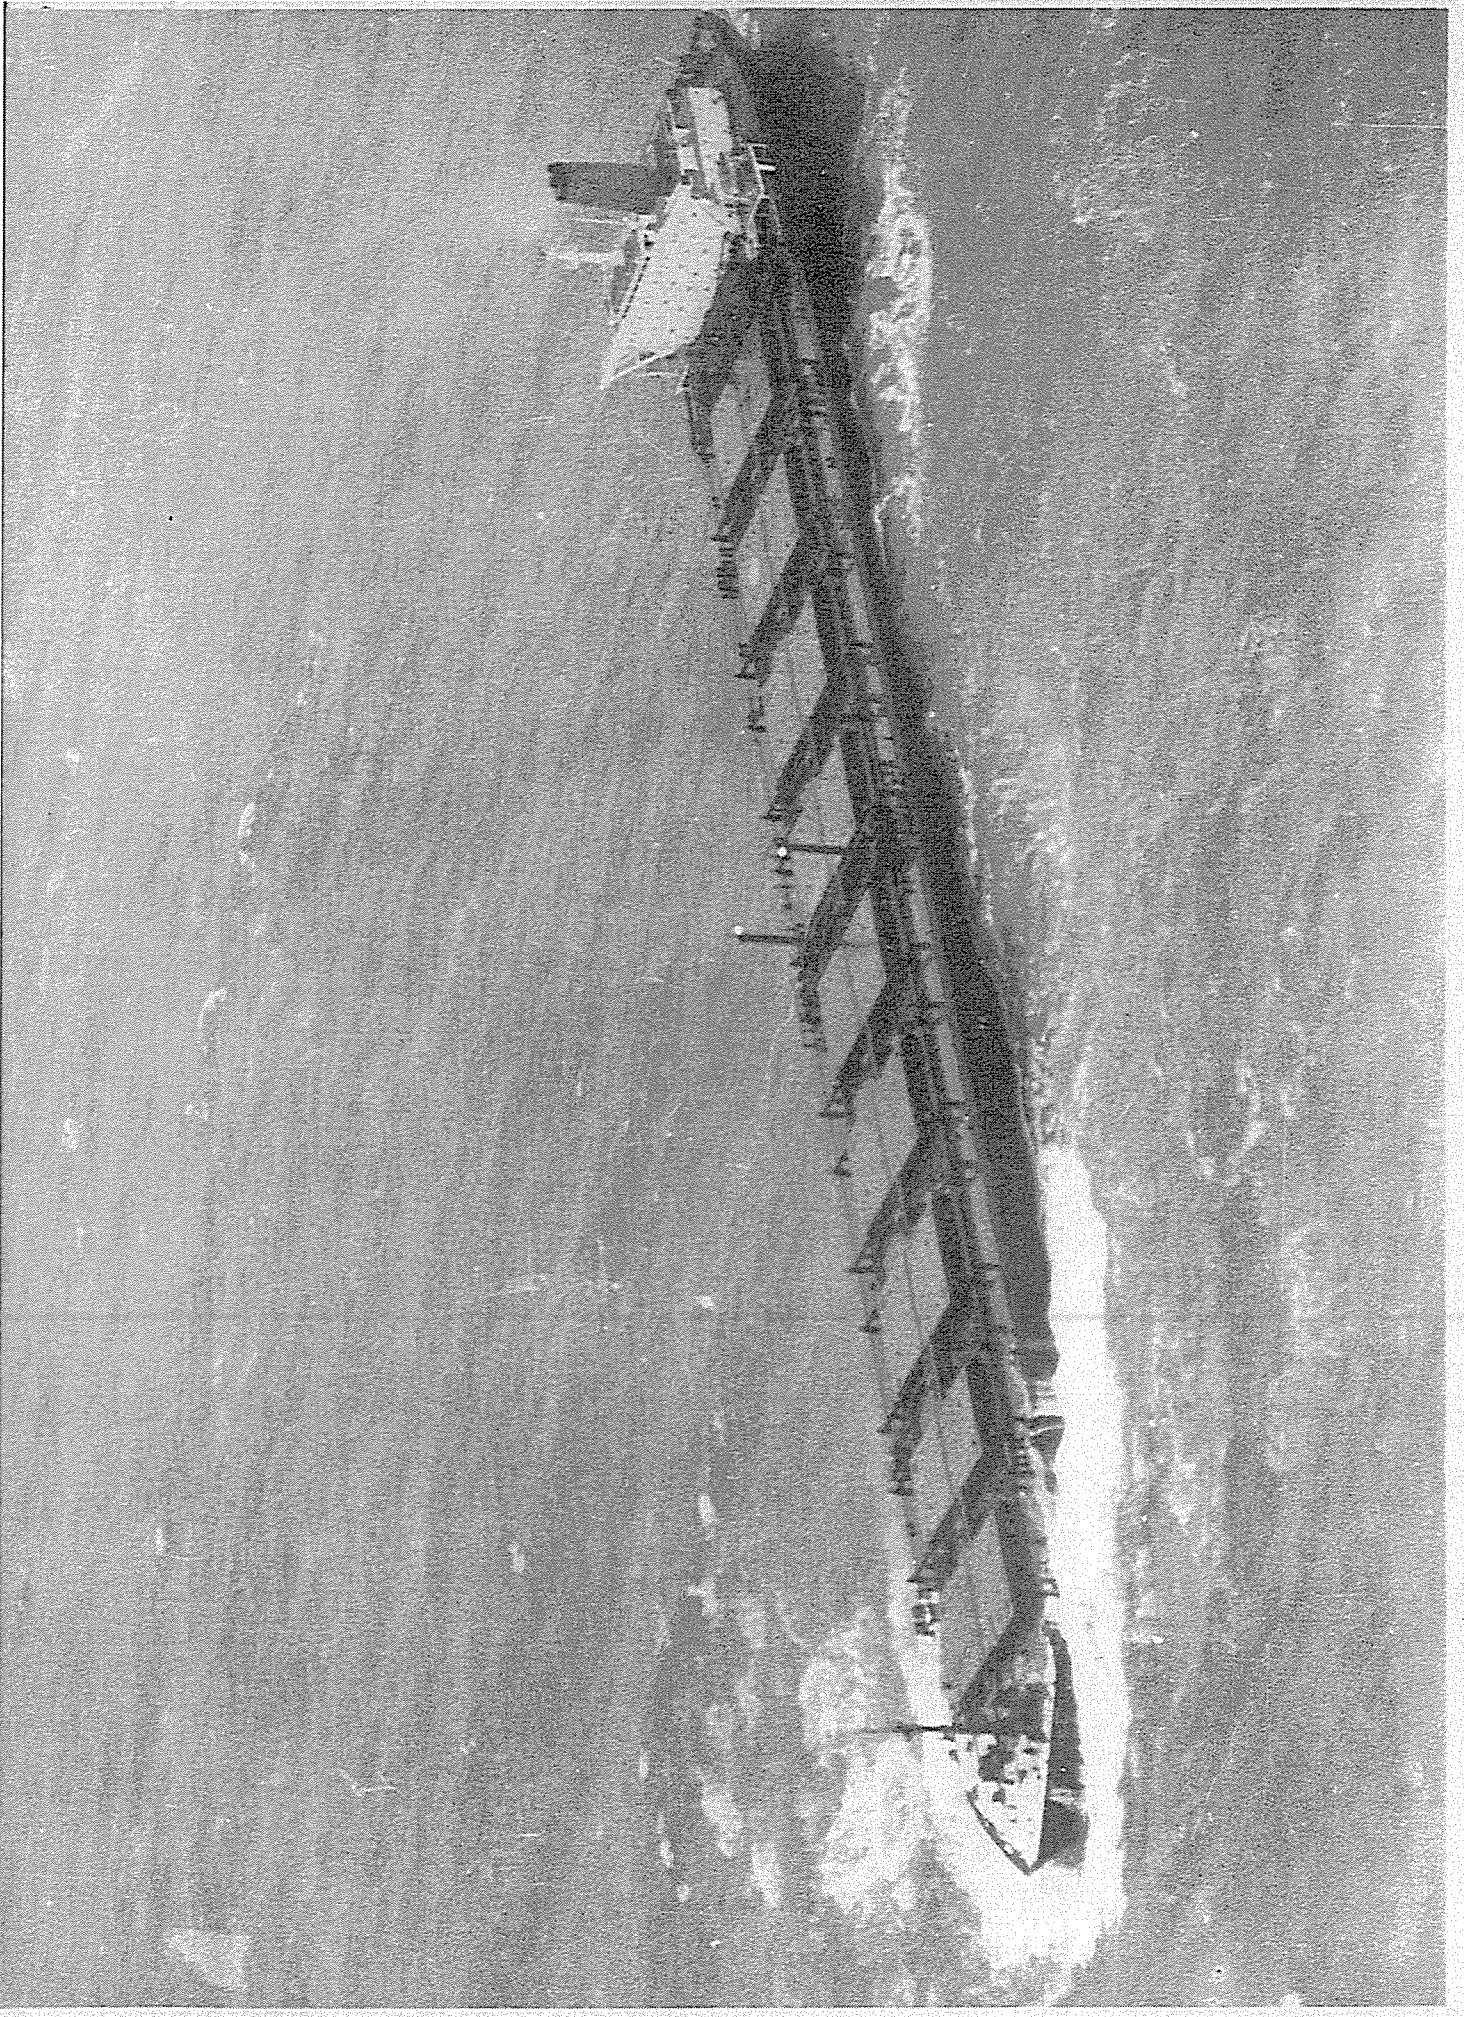
fig. 9 / KOVLOOM BRIDGE / following probable landing forward

It is possible for loads of this magnitude to occur on the forward hatch in storm conditions when a deeply laden ore carrier is hove to (Fig.9). In these conditions and on vessels with low freeboard, no foc'sle and virtually no foredeck, the forward hatch is likely to be more or less permanently awash, and if it loses watertight closure, the forward hold will fairly quickly fill up. For a dedicated ore carrier this is not too dangerous as the hold will already be full of ore and so the vessel is unlikely to trim much more by the bow. On an OBO or bulk carrier, however, the ore may occupy only 1/6 or even 1/10 of the hold, so a very large amount of water

can get in. This trims the bow down, allows green seas to roll up the main deck and places all the hatch covers at risk. This could conceivably happen at night on a large ore carrier without anyone on board realising what has happened. The additional trim due to flooding of the forward hold would only be about 1 degree on a large vessel, almost imperceptible in heavy seas with the vessel pitching. Once the second and possibly third holds have flooded, the vessel will nosedive and sink very rapidly.

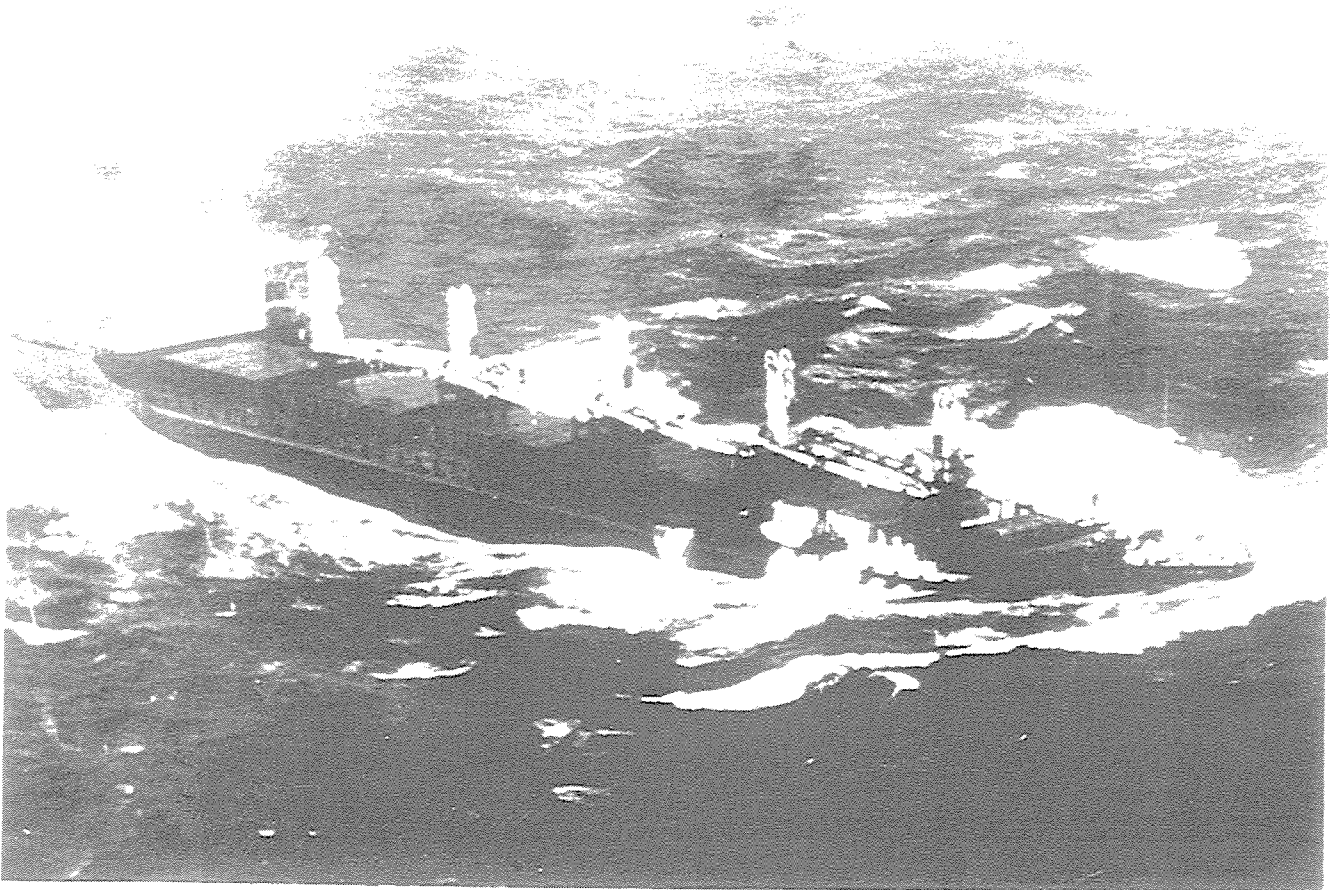
Fig.10 - Marina di Equa

If a bulkhead fails under pressure from a liquid, whether cargo, ballast or due to flooding, a 'domino effect' can occur where several bulkheads all in the same condition fail progressively, allowing a large amount of cargo space to flood. In cases where the source of liquid is the sea, as with flooding through side shell cracks or hatch covers, the loss of the vessel must become a possibility. (See Fig.10).
