**BULK CARRIER LOSSES**  
**A NAVAL ARCHITECTS VIEWPOINT**

**B.J. CORLETT AND J.C. COLMAN**

This Paper discusses some of the background to bulk carrier losses, and in particular the role of structural failure. The principal failures likely to contribute to a total loss and the significance of heavy ore cargoes are considered from a Naval Architect's viewpoint.

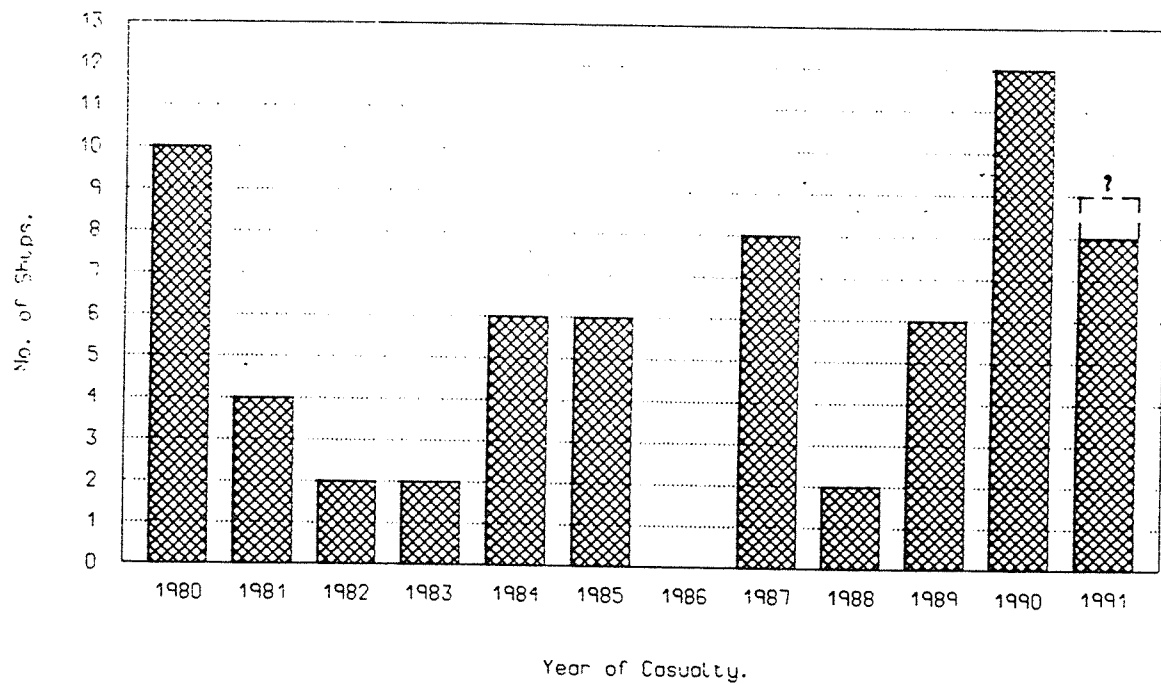
**Fig. 3.**

An examination of the statistics of bulk carrier losses helps to put the significance of structural failure into context. For the period 1980 to 1991, Lloyd's Register have published data illustrating the loss of dry bulk carrying ships, where such losses can be attributed to structural failure, i.e. ships which have had reported hull leakages or have simply gone missing. The ship types include single hull and double hull bulk carriers as well as ore carriers. Over this time period the average rate is about six ships per year with the highest level being 12 ships during the year 1990. Fig.3 illustrates this and Fig.4 shows how the figures are related to size and age of vessels.

**Bulk Carrier Total Losses Where Structural Failure May Have Been A Factor  
(1980 - 1991) 15,000 T. DWT Upwards.**

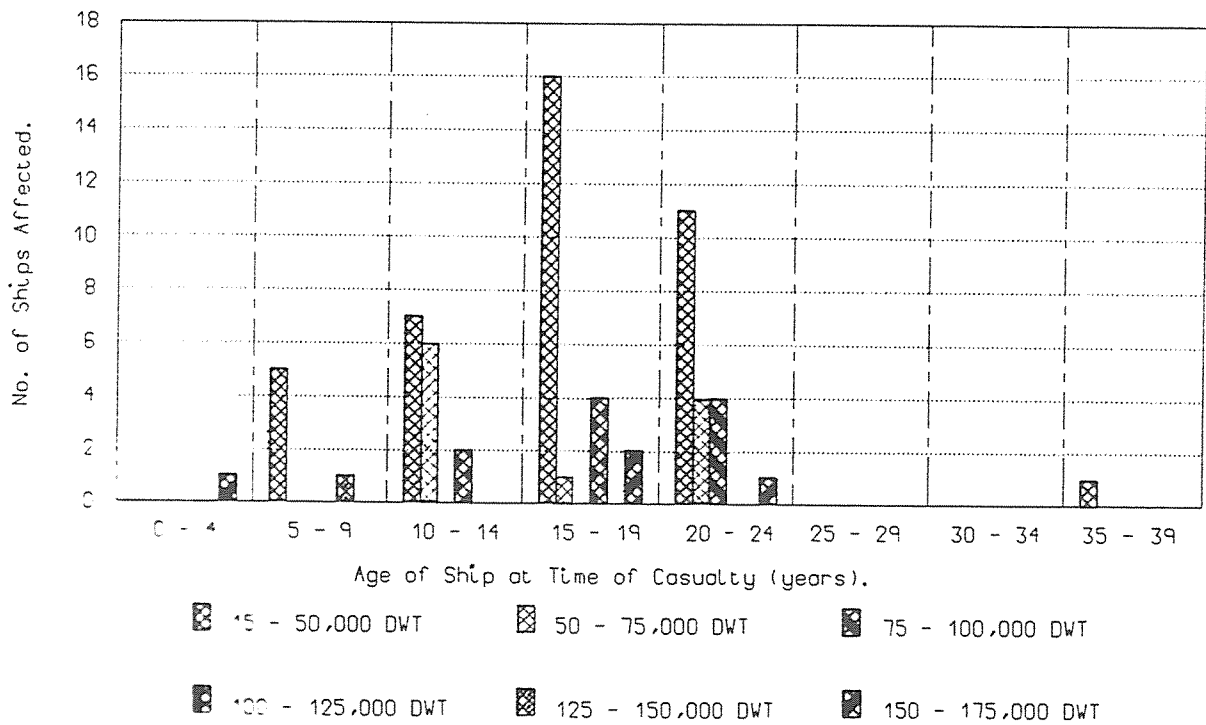
**Fig. 4.**

**Bulk Carrier Total Losses Where Structural Failure May Have Been A Factor.  
on Basis of Deadweight and Age. (1980 - August 1991).**
